# Post-Failure Evaluation Of Wood-To FRP Conversion Of A Crossflow Cooling Tower

Dave Staat, Wade Gelhaus, Chris Castillo  
OBR Cooling Towers

## ABSTRACT

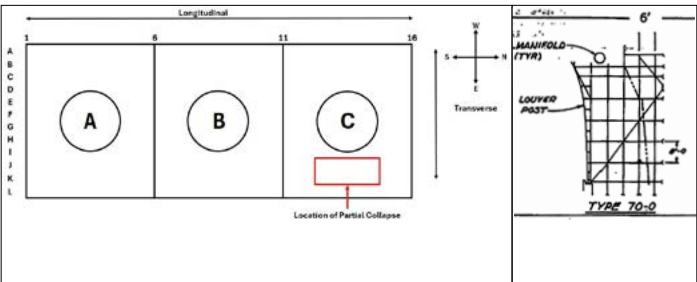
The cooling tower was originally an Ecodyne Series 70 crossflow cooling tower constructed with wood framing. In 2023, a contractor undertook a retrofit project to replace the wetted-section framing of one cell with FRP components. During this process, the original curved louver post design was eliminated and replaced with a straight louver configuration (see Figure 1 below).

Figure 1: Cooling Tower Overview (left), Curved Louver Column Design (right)

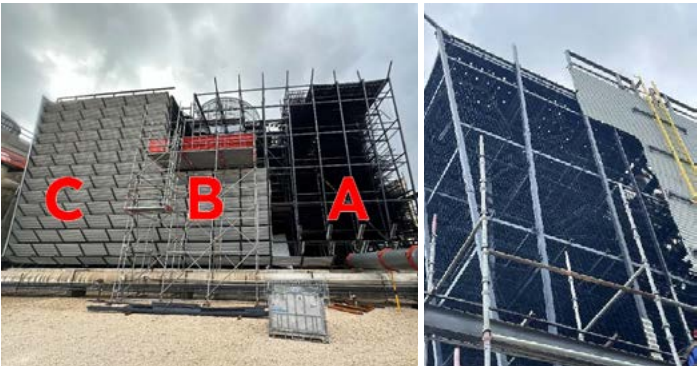
Figure 2: Cooling Tower Undergoing Diagonal Brace Fix (left), Diagonal Brace Fix Overview (right).

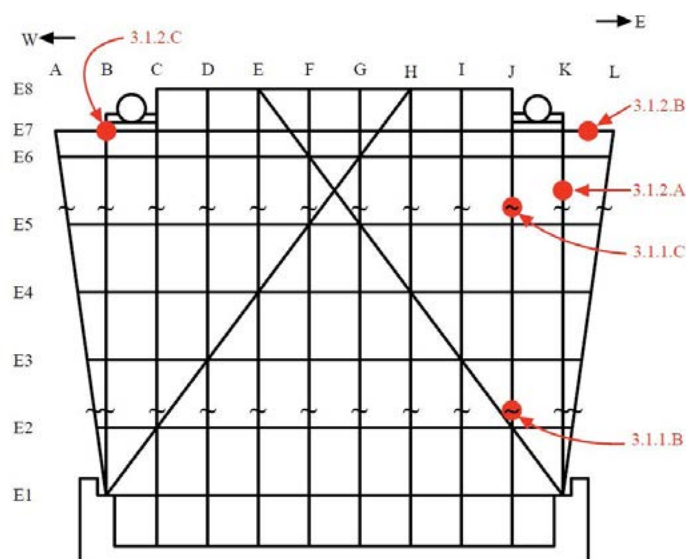
Figure 3: Bent Sketch Illustrating Failure Locations.

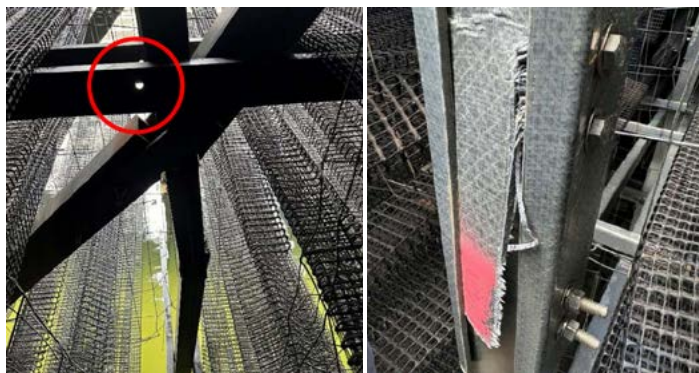
- Several instances of column buckling were identified, including one column that had dropped approximately 127 mm (5 in).
- At the primary failure location, missing bolts at a column, tie, and brace connection created an unsupported column length of nearly 4.88 m (16 ft), well beyond acceptable limits.
- Compression failures at column splices were noted in four separate bents, indicating systemic weakness at splice details.

Figure 4: Failed Column Member & Missing Connection Hardware (left), Compression Failure (right).

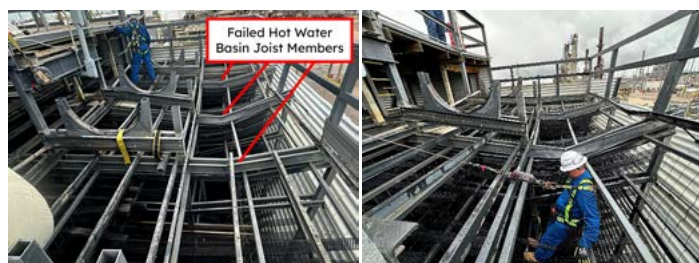
- The number of mid-bay nailers was insufficient; joist spans exceeded typical industry spacing, with intervals measured at approximately 0.61 m (2 ft). This lack of adequate lateral restraint increased the likelihood of deflection and connection overstress.
- Hot water basin joists and their supporting channels spanned approximately 1.83 m (6 ft) without compression blocks between members. Compression blocks are critical in this configuration to prevent inward buckling, distribute load evenly, and provide restraint against torsional rotation under basin water loads.
- Plowing and cracking were observed on 140 mm (5.5 in) FRP channel joist supports, which were connected to columns with a single fastener instead of the industry-standard double-bolt configuration. The reduced connection capacity contributed to localized overstress and premature material damage.

Figure 5: Partial Collapse at Hot Water Basin Level.

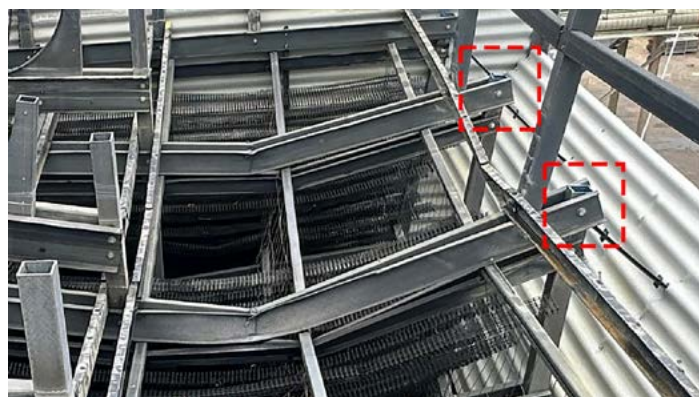
Figure 6: Single Bolt Configuration on Hot water Basin Joist.

Connection detailing throughout the retrofit further weakened the system. Joist supports fabricated from 140 mm (5.5 in) FRP channels were connected to columns using only a single bolt. The analysis demonstrated that this configuration could not meet minimum safety factors. The limited bearing area resulted in overstress and was consistent with the plowing and localized cracking observed in the field. Proper double-bolt connections, which distribute load more effectively and provide redundancy, were not used.

- Connection detailing, particularly the use of single-bolt joist supports, was insufficient to meet minimum safety factors and directly correlated with observed plowing and cracking at FRP channels.

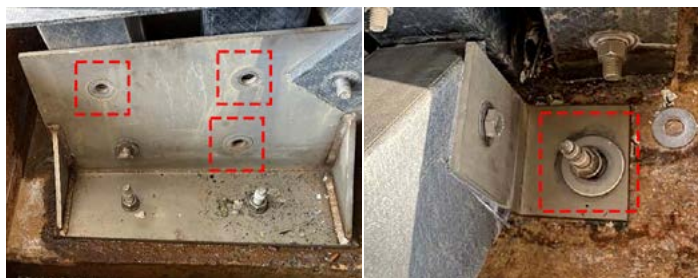
1. The first inspection, conducted on the east side of Cell C, revealed that brace connections did not match the issued design details, hardware was missing at base anchors, anchor bolts were undersized, bearing plates were absent at column splices, and one tie had been improperly installed. These observations demonstrated both design omissions and construction errors that would have gone unaddressed without independent QA/QC oversight.

Figure 9: Missing Hardware on Base Anchor (left), Undersized Anchor Bolt (right)

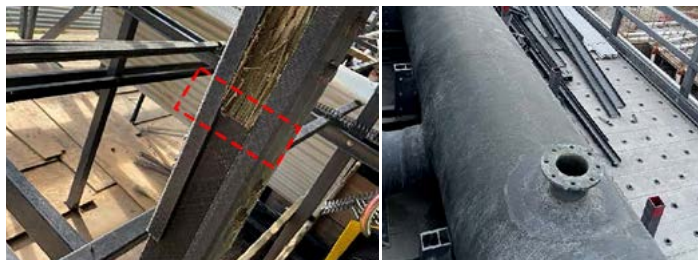
2. The second inspection, covering Cells B and C, confirmed that some corrections were made but also identified outstanding issues. These included an uninstalled header standpipe on the west side, insufficient fastening of the longitudinal air seal wall, and missing fan deck mid-bay supports that represented a safety hazard.

Figure 10: Missing Bearing Plate (left), Uninstalled Standpipe (right)

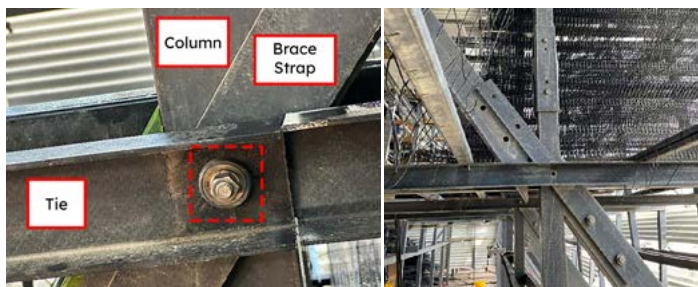
- Shear bushings were installed through multiple members in a manner that placed the bushings in shear. Although no failures were observed during field inspections, this detail raised concerns as it could not be reliably tested or analytically validated. The configuration introduces shear demand on the bushing material, representing a potential point of weakness. Refer to Figure 11 below.

3. The third inspection, performed on Cell A, reiterated concerns with brace connection details and missing FRP bushings, documented misaligned base anchor hardware, and noted absent bearing plates at column splices. Multiple failed wood ties, though outside the contractor's defined scope, were also recorded as structural concerns. Finally, the fill media review found missing rows of splash fill bars requiring correction.

Figure 11: Bushing Installed at Column, Brace and Tie in Shear (left), Brace Strap Missing Hardware (right).

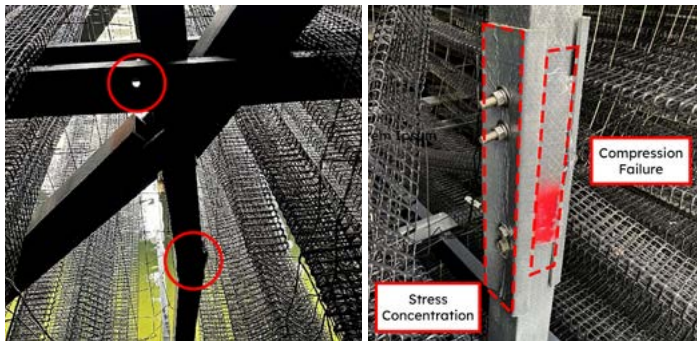
While the key findings identified deficiencies in material quality, structural design, and installation, it was the interaction of these deficiencies that produced the collapse. The sequence of failure most likely initiated at a column splice on the east side of Cell C. Missing bolts at the splice left an unsupported length of nearly 4.88 m (16 ft). Without bearing plates to distribute load, stress was concentrated at the bolt holes, accelerating localized crushing. The resulting instability caused the column to buckle, dropping the fan deck by approximately 127 mm (5 in).

Figure 12: Missing Bolt Contributing to Buckling, Compression Failure at Splice with No Bearing Plate

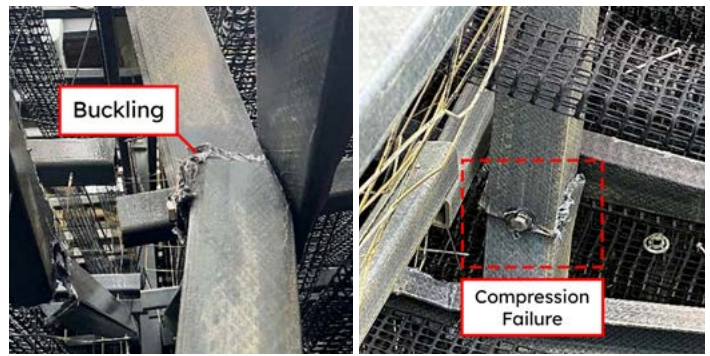
Figure 13: Column Member Exhibiting Buckling (left), Column Member in Compression Failure (right).

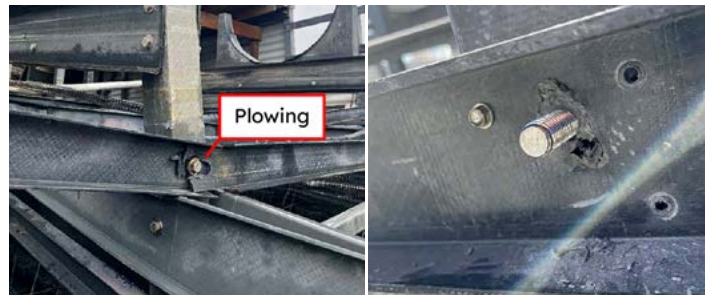
As the column failed, loads were redistributed into the adjacent framing system. Basin joists and diagonal braces, already operating near or above capacity under ASCE7-16 loads, were suddenly overstressed. The absence of required hardware at the brace connection attributed to the column buckling. At the same time, single-bolt joist supports began to plow at their channels, and the absence of compression blocks allowed joists to rotate and buckle inward.

Figure 14: Hot Water Basin Joist Exhibiting Plowing (left), Missing Hardware & Plowing of Member (right).

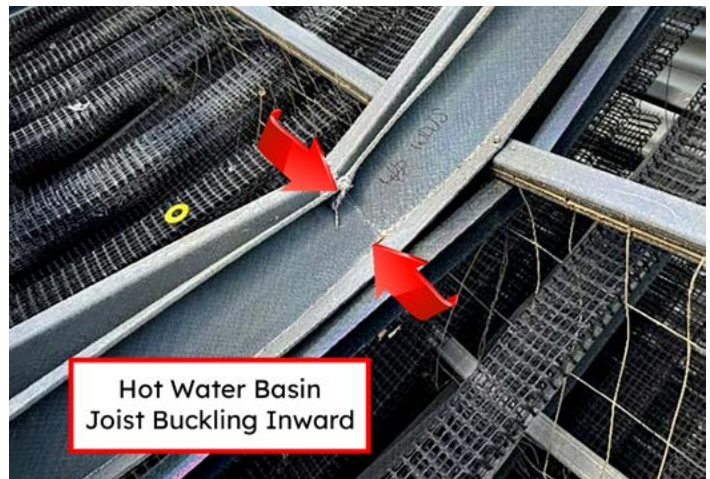
Figure 15: Hot Water Basin Joist Buckling Inward.

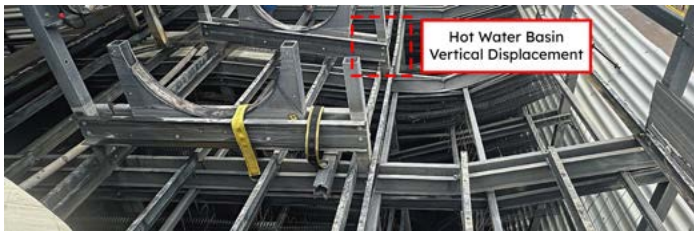
This progression produced a cascading collapse: column instability led to overstressed braces, brace failures transferred load to under designed joists, and joist failures allowed the basin framing to deform and twist, ultimately pulling the system into progressive failure across the east side of the cell.

Figure 16: Hot Water Basin Supports Vertical Displacement.
