# Post-Failure Evaluation Of Wood-To FRP Conversion Of A Crossflow Cooling Tower

Dave Staat, Wade Gelhaus, Chris Castillo  
OBR Cooling Towers

## ABSTRACT

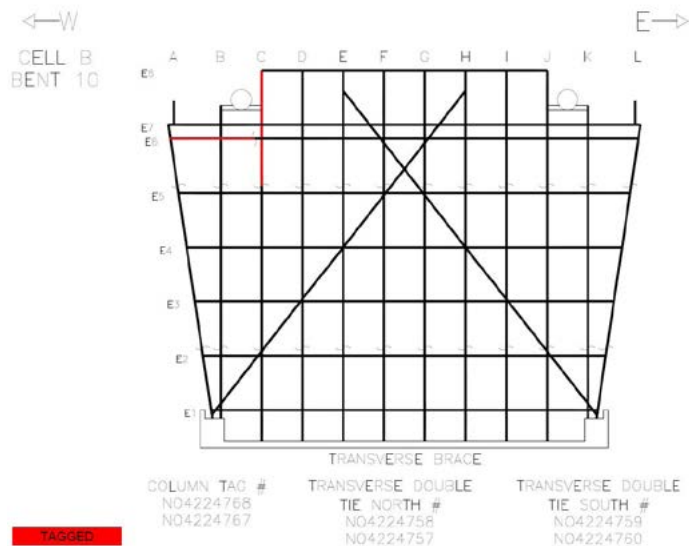
Figure 7: Example Bent Sketch Illustrating Sample Member Location.

- Tamper-resistant labels were applied to designated members prior to removal for material testing.
- Two dimensional bent sketches were generated to record framing geometry and sampling locations.
- Inspection procedures included detailed visual assessments, torque checks on bolted connections, and measurement of member spans, alignments, and splices.

Key observations included misaligned columns, improperly field-cut FRP members, missing hardware, and inconsistencies in connection detailing. These findings confirmed that installation quality issues compounded the structural vulnerabilities inherent in the retrofit design.
